APPENDIX E: ARCHITECTURAL AND INTERIORS ASSESSMENT

Finishes and Overall Appearance

Coliseum

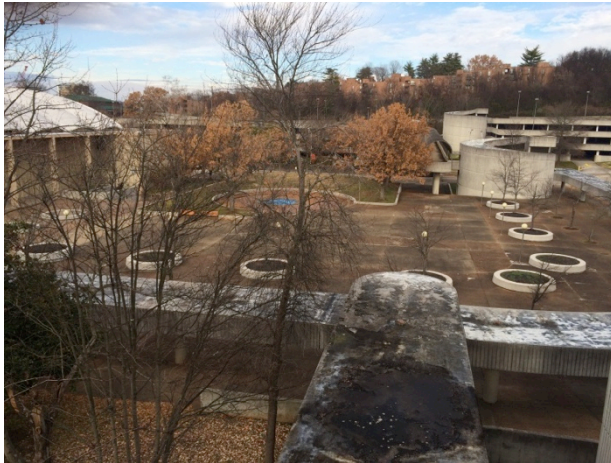
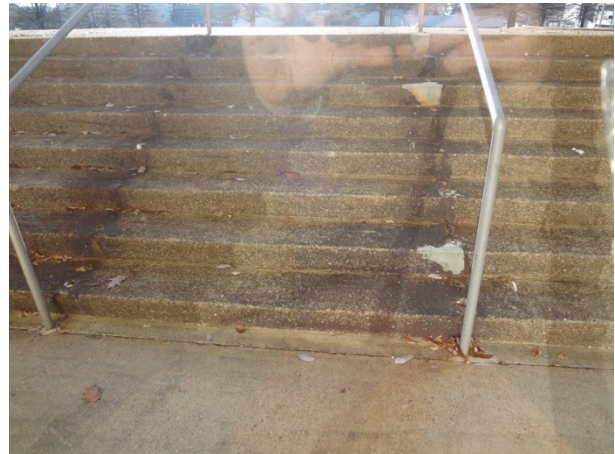
Exterior plaza, stairs and breezeway areas need patching, painting & re-finishing. Deterioration has begun in some locations.

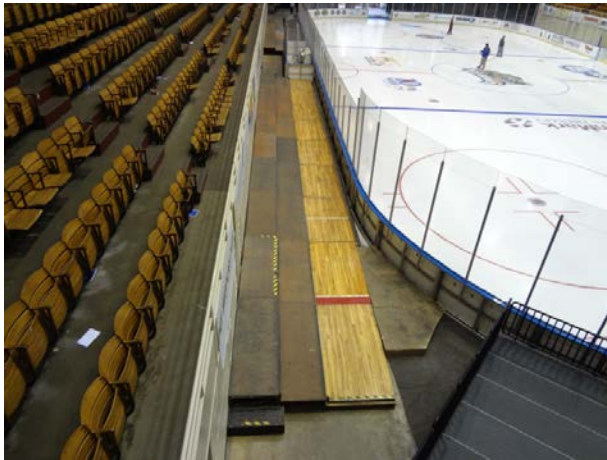
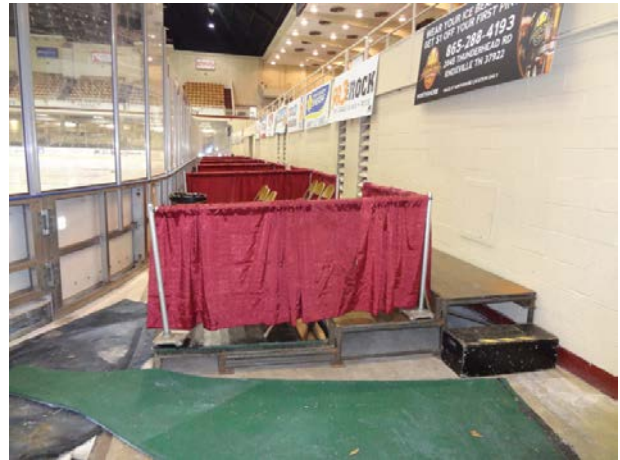
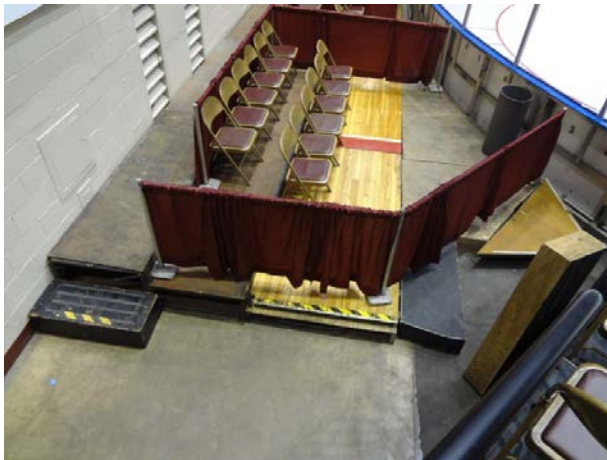
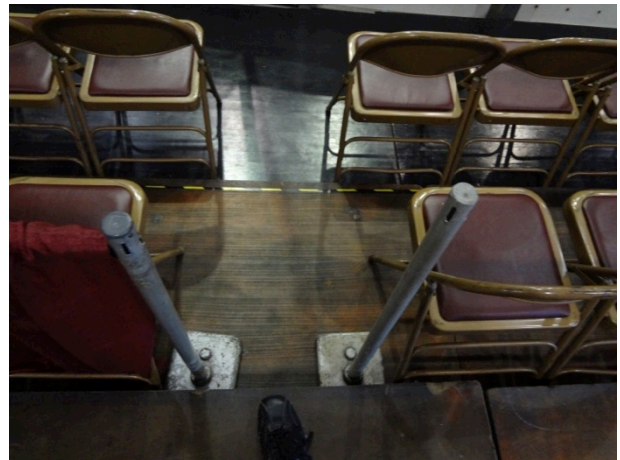
Loge boxes and temporary seating set up for ice hockey games do not meet code and presents a safety concern. Code compliant retractable risers and seating should be provided. Also, ADA accessibility must be a priority for the seating and furniture as well.

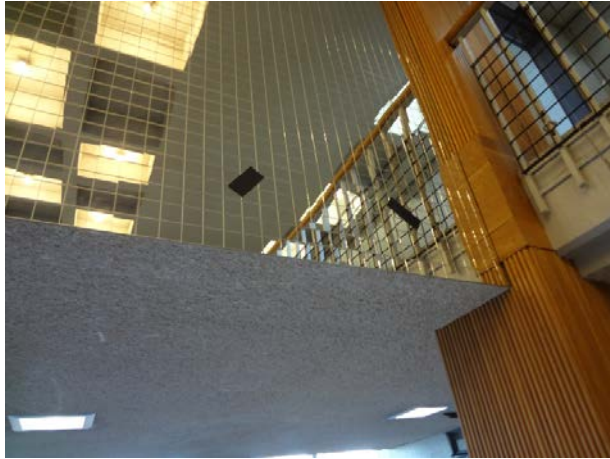
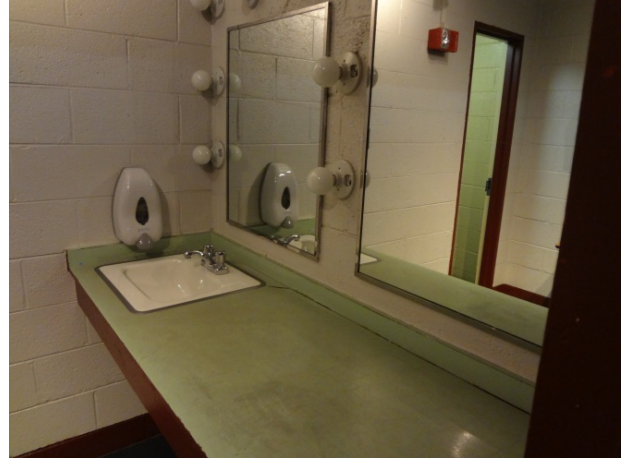
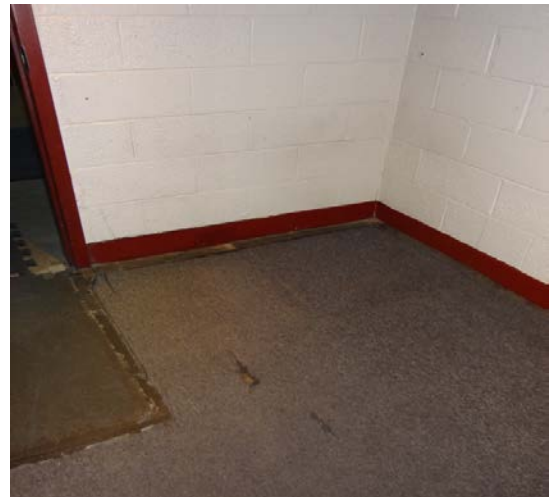
Overall finishes are out of date for the entire Coliseum. Areas in the star dressing rooms and visitor's locker room are especially deficient. Many of the restrooms have toilet dividers that need repair/replacement. Back of house spaces include plumbing fixtures are in need of replacement. There are also areas that pose a safety concern (ex. tile in atrium hallway – taped to wall. Concern that tile could fall from wall).

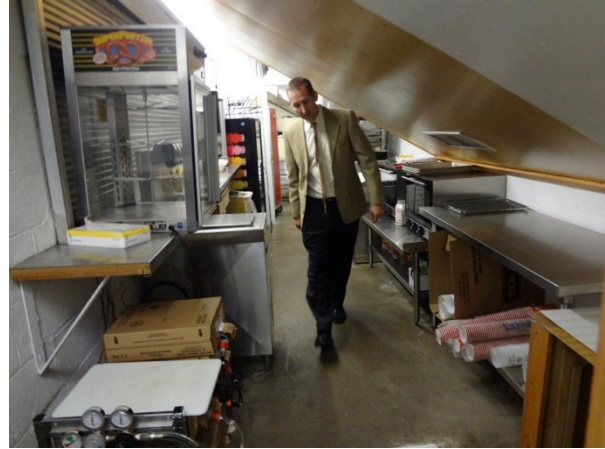
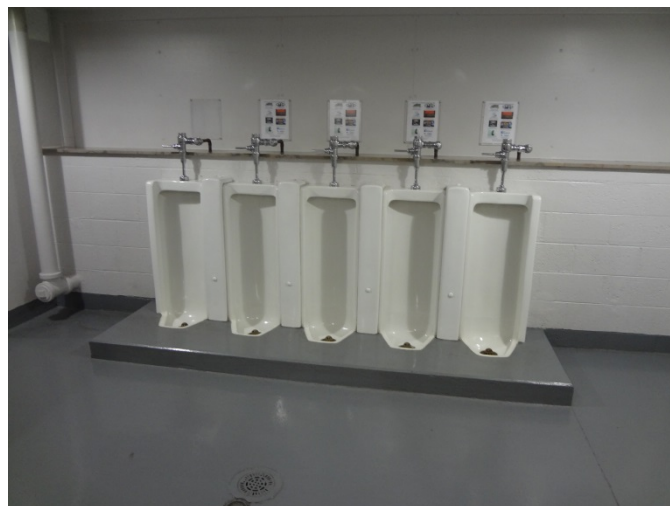
The facility needs to be upgraded from an ADA perspective. Increasing ADA toilet counts, increasing ADA concession counts, access to many of the event level areas (ex. star dressing rooms and locker rooms), access from event level to other levels – passenger elevator would be beneficial, also some of the interiors of the east and west concessions are not accessible from a disabled worker's standpoint.

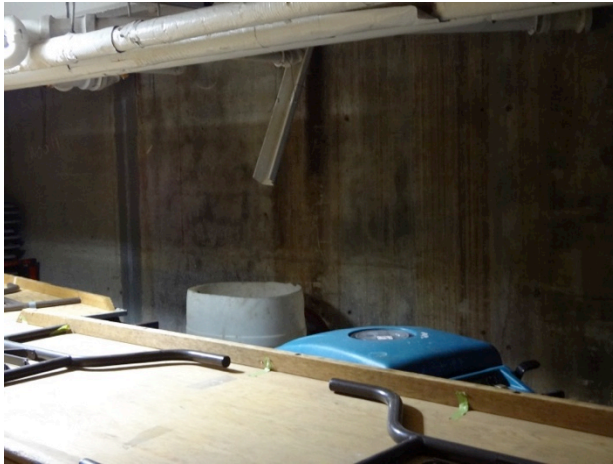
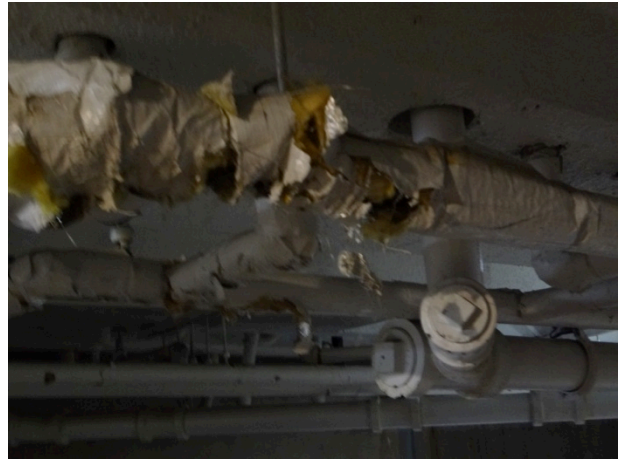
Major leaking and water infiltration on event level exterior walls. Patching has been done but water still finding its way in, so repair to areas is necessary. This leaking is also causing the nearby MEP and ductwork to deteriorate.

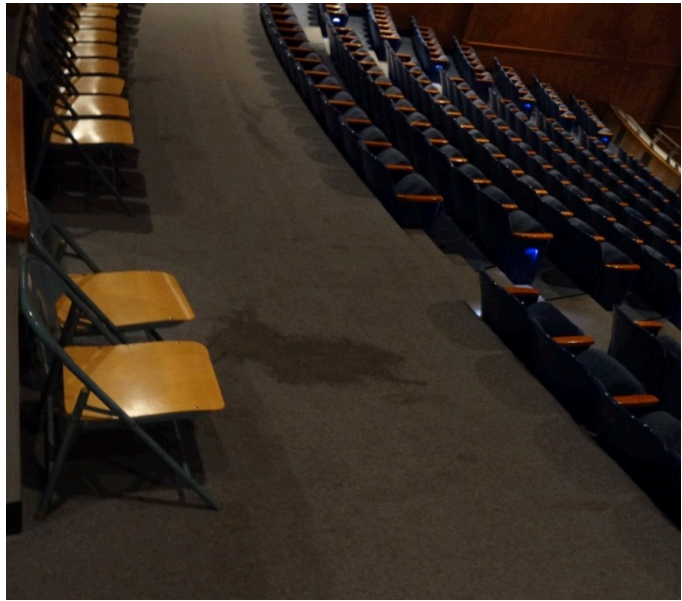
Loading dock has several large leaks and standing water. Repair to area is necessary.

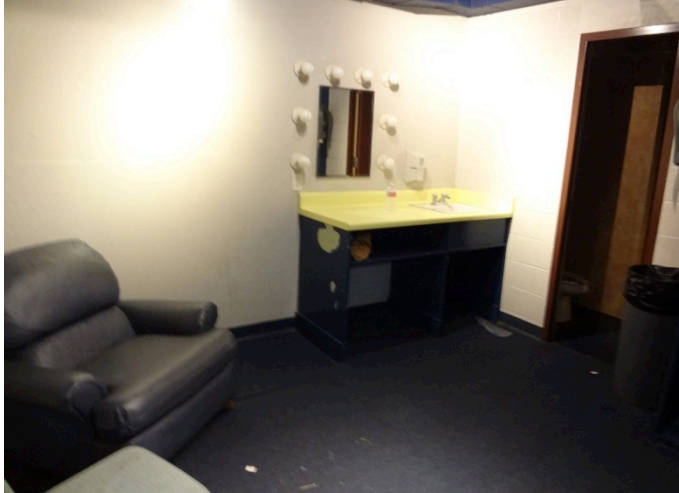
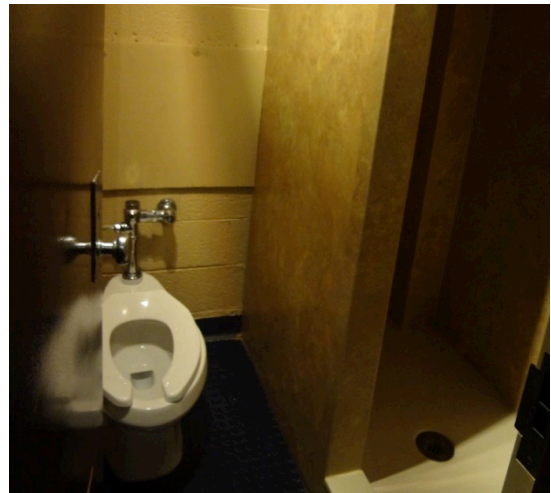
Green room is severely out of date from a finish standpoint and lack ADA toilet access.

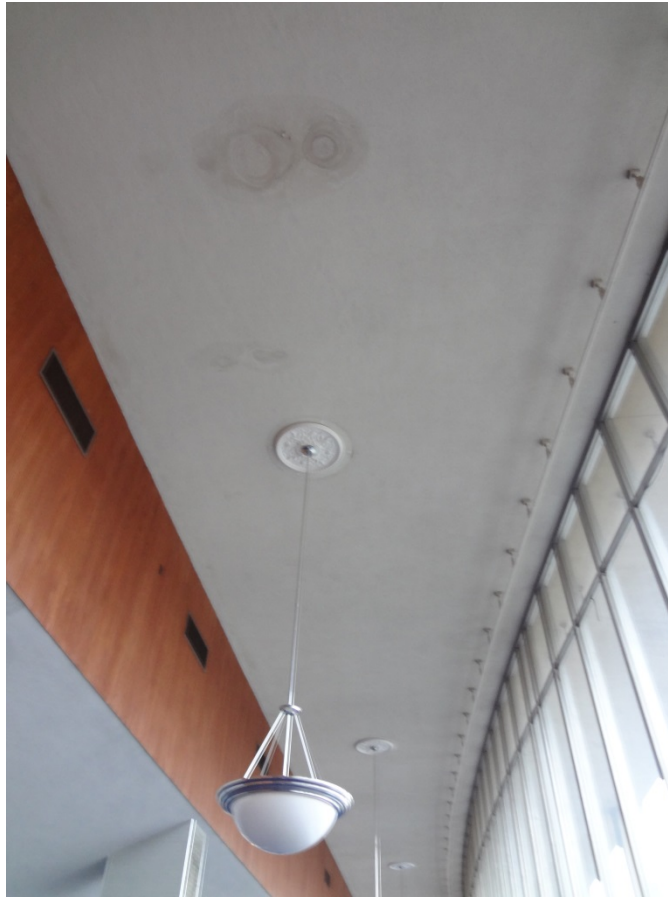
Major staining showing on ceiling of Auditorium atrium – building manager indicates roof leaks have been repaired, so this is a cosmetic issue.

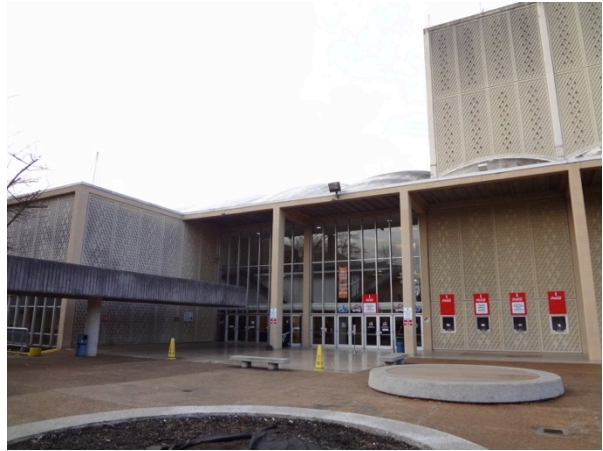
- Precast joints require re-sealing and regular examination/maintenance.
- Currently the panels under the overhangs at the east & west sides are in better condition than their exposed counterparts. Exposed precast panels show fair amounts of discoloration, indicating likely moisture infiltration.

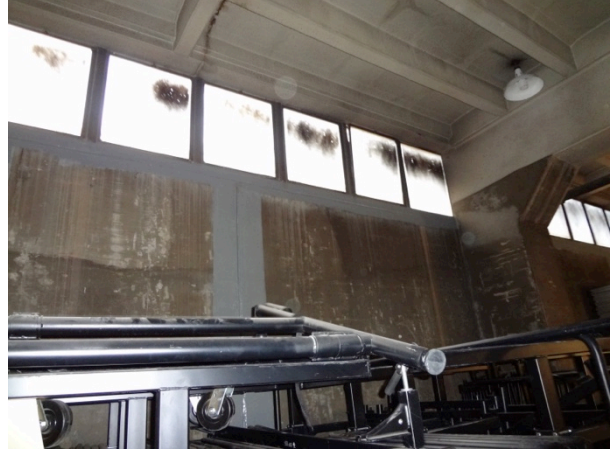
- Curtain wall and storefront glazing are single glazed systems. The system is in need of general maintenance including re-sealing/gasketing of glazing panels in a number of locations. The curtain wall frame itself appears to be stable. Glazing is in differing amounts of disrepair, including damage in the primary Auditorium entry façade.

- The single-glazed systems are likely taxing the current MEP systems and compromising the energy efficiency of the facility as a whole. We would recommend replacing the current glass with insulated glazing units.

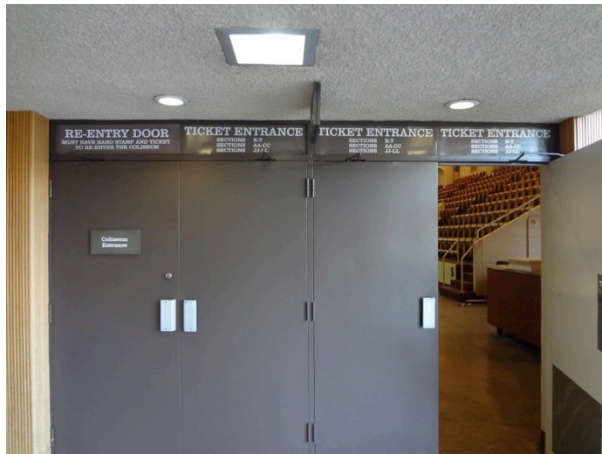
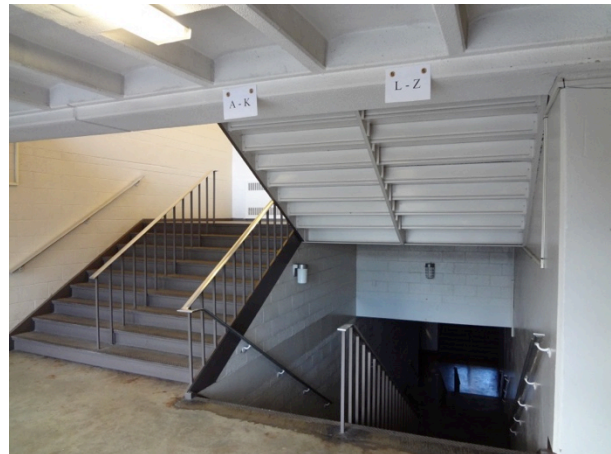
Way finding and signage overall should be more uniform and clear. Overhead signage at entries is inadequate in size & clarity to properly direct spectators to their seats. In addition signage at stair locations lacking permanent signage, as current signs are made of paper.

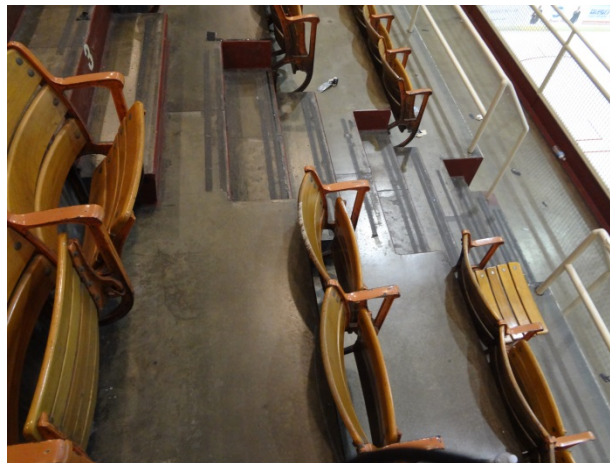
- Many of the wood slat seats are in disrepair. Self-rising mechanism have failed & material finishes are worn. This failure reduces the effective aisle width of the seating sections.
- While the seats themselves are an interesting character element for the age of the arena, they should be replaced with seats of those of modern standards & ergonomics.
- Seating aisles are narrower than current code requirements.
- Seating aisle steps have riser & tread dimensions that do not meet code. Aisle steps have tread depths of 10" at north & south sides and 8" at east & west sides.

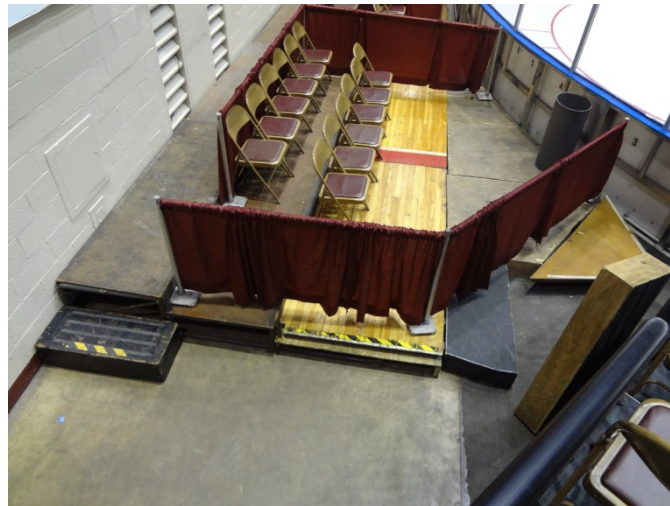
- Portable platforms at hockey sideline are built of combustible materials & not suitable for use. Use of temporary rails in these areas is inappropriate as well.

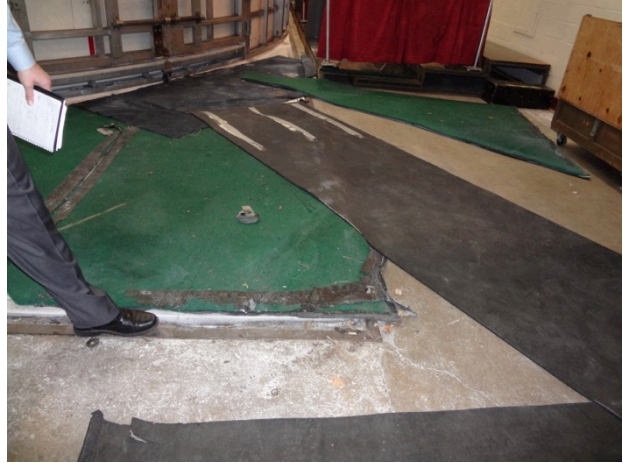
- Temporary floor coverings around floor seating need replacing and better planning. The current condition creates a number of accessibility hazards. Materials are torn, stained, & incoherently installed.

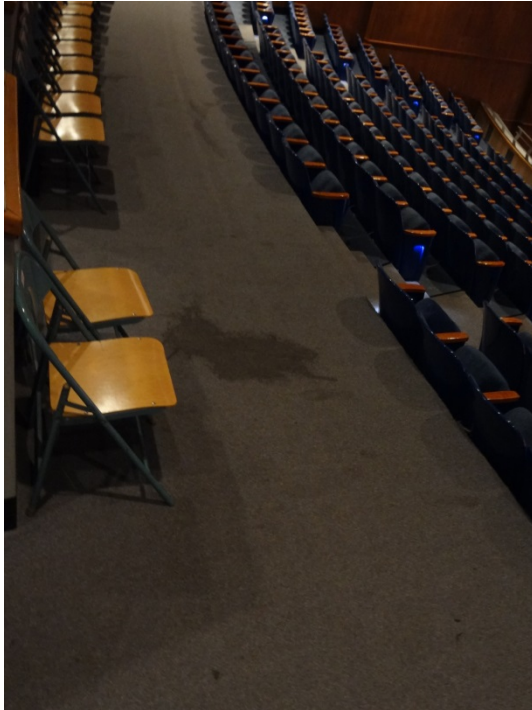
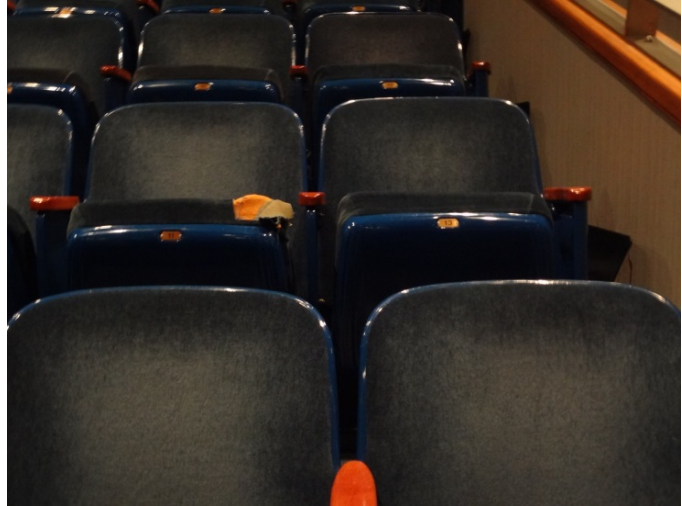
Seat materials have deteriorated. Many seats have torn fabric seats with exposed foam padding. Self-rising mechanisms need maintenance.

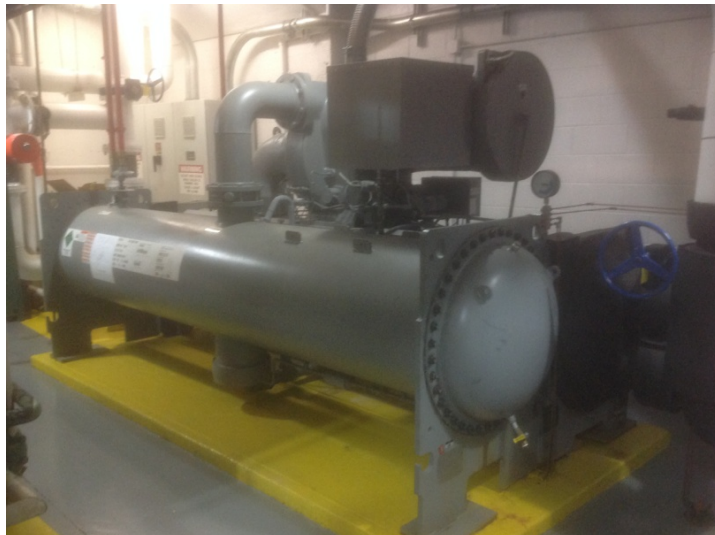
M.2 430 ton chiller

The chillers appear to be in good to fair condition based on their respective ages. The condenser tubes are brushed every year and the machines appear to be well maintained.

The median useful life span of a chiller is between 18 and 23 years. Therefore, the 300 ton and 60 ton chillers are well past their service life and should be replaced. A proactive maintenance routine for the chillers is essential to extend their useful life; however, as time passes, the chillers will become less energy efficient even with the best of service practices.

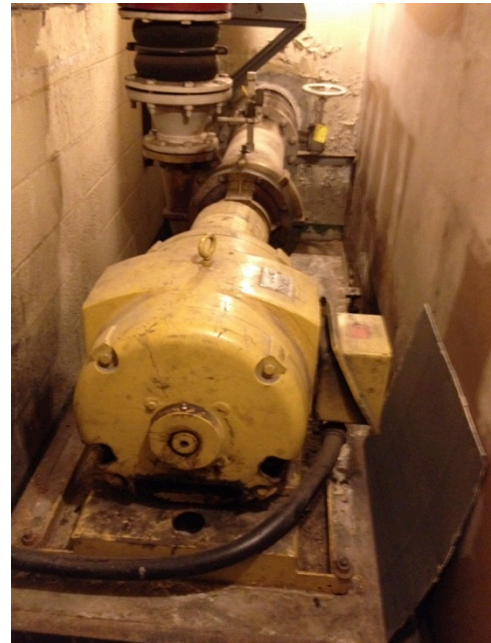
M.8 Condenser Water pump

Condenser water pumps appear to be in fair to poor condition. The median useful life of the condenser water pumps is also between 20 and 21 years and these pumps should be replaced.

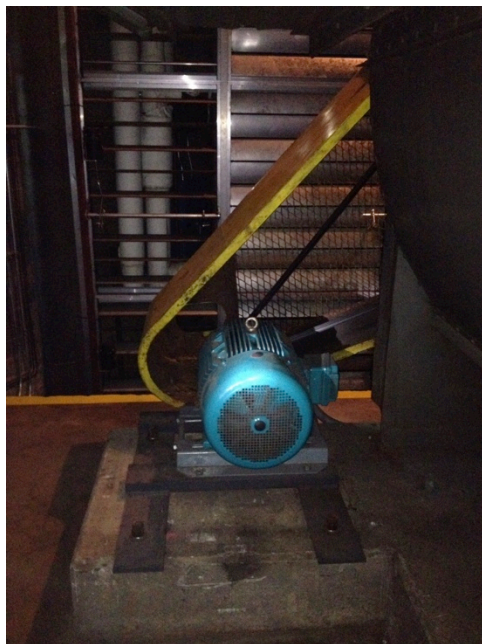
M.15 Bowl AHU Supply Fan

The air handling units serving the Auditorium and Coliseum include an air side economizer function which, when activated, pressurizes the respective space. Relief air is accommodated by exhaust fans on the roof in the Coliseum and by roof mounted relief hoods in the Auditorium. These relief systems are in poor condition and some of the Auditorium relief hoods are apparently closed by weights due to water leakage issues.

The air handlers and their associated components appear to be in reasonable condition considering their age and runtime. Filter media is cleaned annually, but is low filtration efficiency type. Cooling coils were relatively clean and several of the units have added UV lights to maintain coil cleanliness. Condensate drain pans were reasonable with little signs of biological growth. The motors were in good condition.

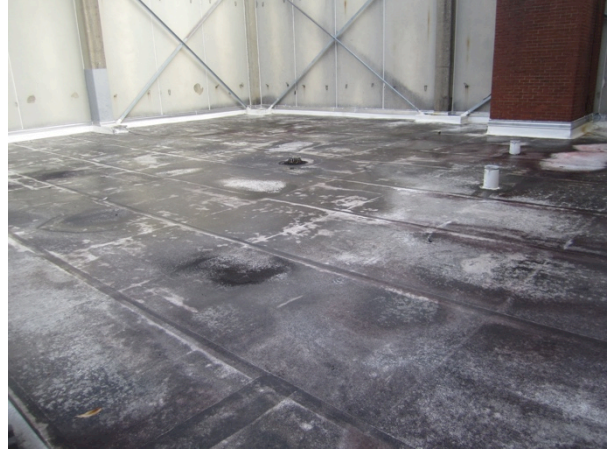
Weights used to keep exhaust doors from allowing rain penetration. Very dirty membrane surface.

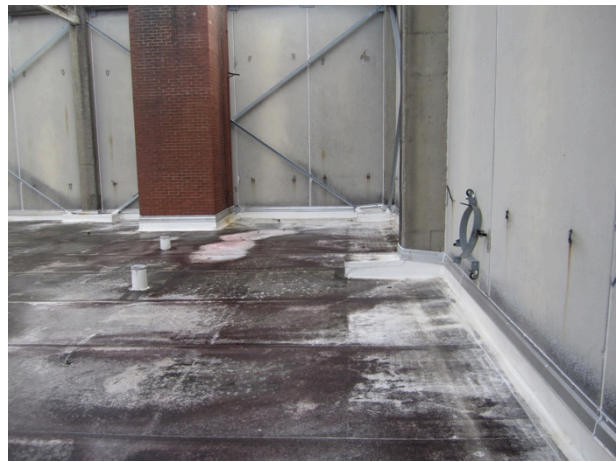
Abandoned blue tarp observed between exhaust vents.

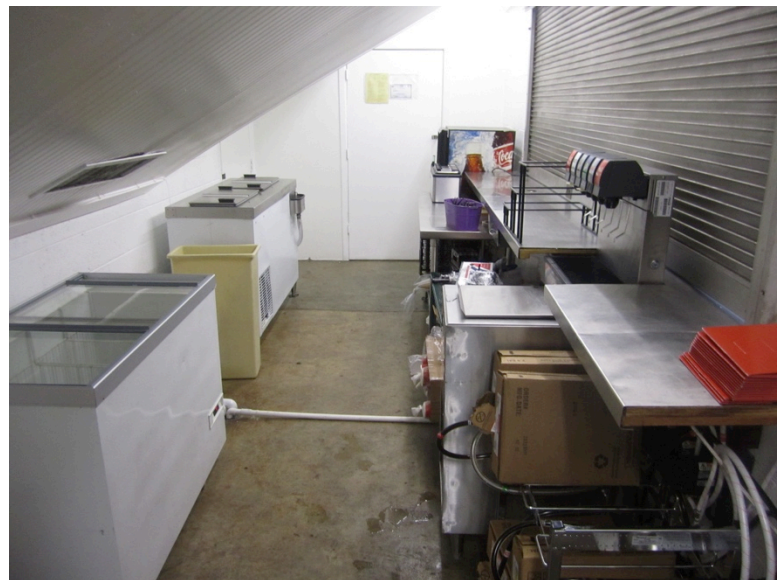
Freezers were the main equipment in the dessert stand, and they were in good condition. We recommend ramping over the PVC drain that extends across the walkway in order to minimize the trip hazard as well as protect the pipe.
