APPENDIX E: ARCHITECTURAL AND INTERIORS ASSESSMENT

Finishes and Overall Appearance

Coliseum

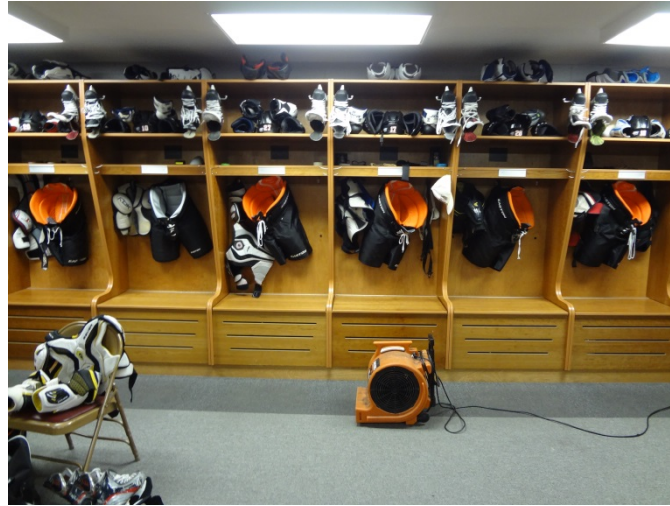
Recommendation for increasing HVAC ventilation – providing super heat for Ice Bears locker room – to reduce the amount of moisture and odor in locker room.

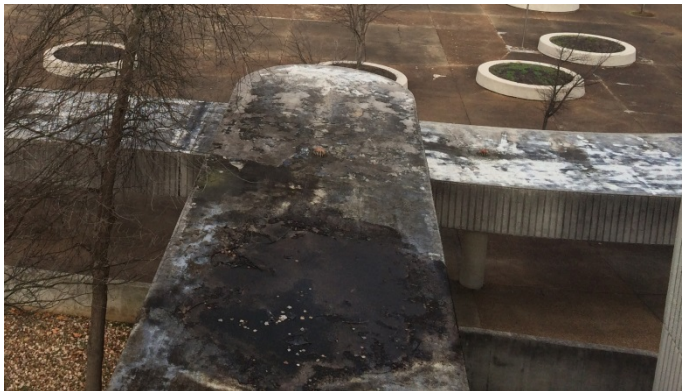
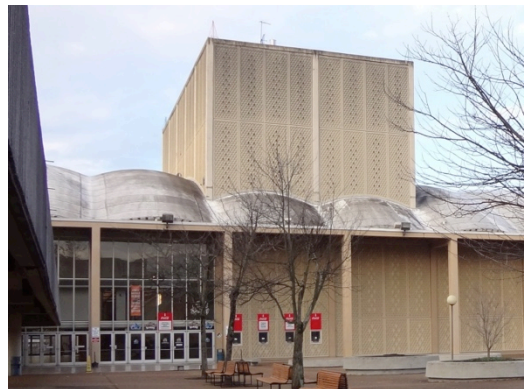
- Roofing materials are in need of cleaning and maintenance. Visible debris at a number of roof drains, including those on canopies and breezeways visible to the public. Full evaluation may be required, though most current issues appear to be aesthetic.

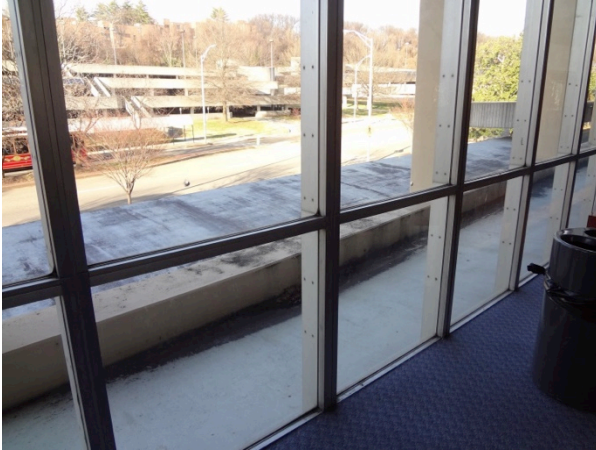
- Curtain wall and storefront glazing are single glazed systems. The system is in need of general maintenance including re-sealing/gasketing of glazing panels in a number of locations. The curtain wall frame itself appears to be stable. Glazing is in differing amounts of disrepair, including damage in the primary Auditorium entry façade.

- The single-glazed systems are likely taxing the current MEP systems and compromising the energy efficiency of the facility as a whole. We would recommend replacing the current glass with insulated glazing units.

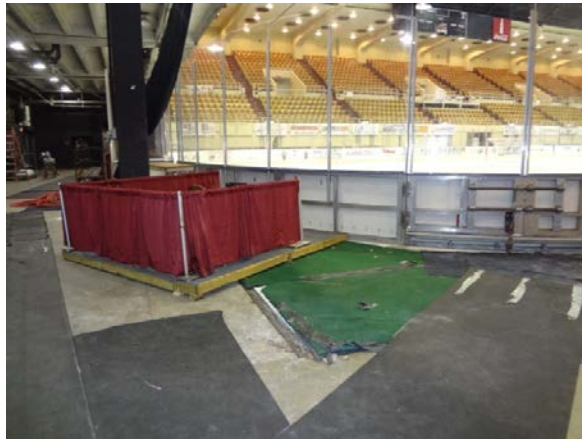
- Seating in (4) corner sections of the north & south seating areas have severely compromised views for many event types. This has negative impact on spectator experience and potential revenue for particular show configurations.
- The Coliseum contains no true premium seating amenities. Temporary loge style boxes at floor level are inadequate for current market standards. Lack of premium amenities represents a potential loss in revenue for the facility.

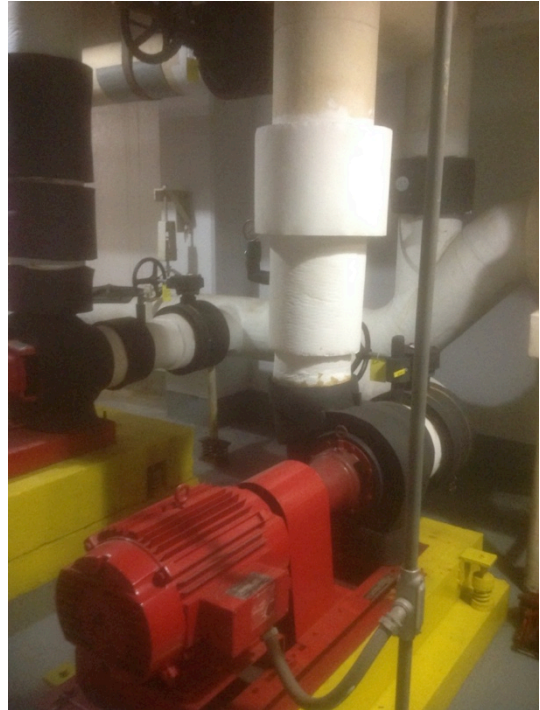
M.5 Chilled water pumps

Chilled water pumps appear to be in average condition. The median useful life of the chilled water pumps is between 20 and 21 years, the pumps have exceeded their useful life and should be replaced.

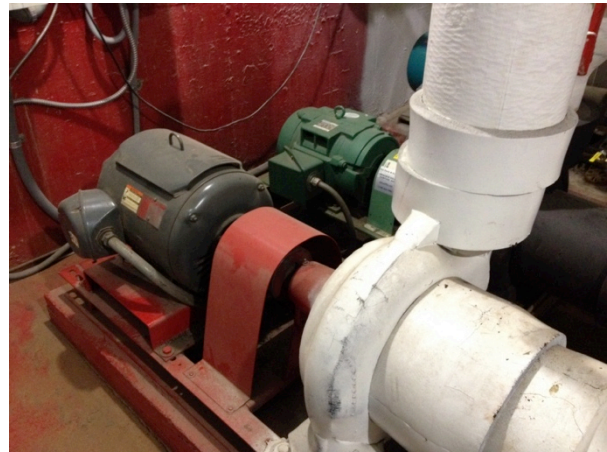
M.11 Steam condensate pumps for hot water heat exchanger M.12 Secondary Heating/Cooling water Pumps

Hot water pumps appear to be in fair condition based upon their age. The median useful life of the hot water pumps is between 20 and 21 years. Therefore, the primary loop heating water pumps appear to be close to the end of their service life.

Boilers are one of the largest energy consumers for the arena. As such, the boilers should be a priority for preventative maintenance and service planning. Heating hot water pumps should be completely replaced in 5 years.

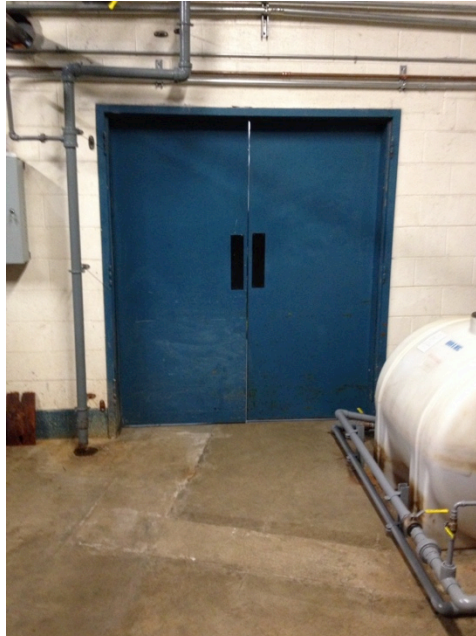
M.19 Ice Chiller Room doors

The ice chiller room doors appeared to remain typically closed between this room and the primary chiller room. These doors should remain open since the refrigerant leakage exhaust system is in the primary chiller room and the make-up air duct is in the ice chiller room. The refrigerant monitor is also located in the ice chiller room and this device is intended to monitor both rooms. Otherwise, the building systems seem to be well-maintained.

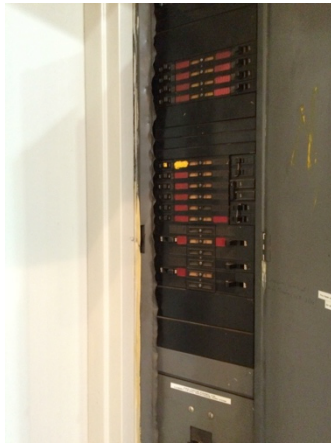
E.5 Electrical Panel Showing Considerable Wear.

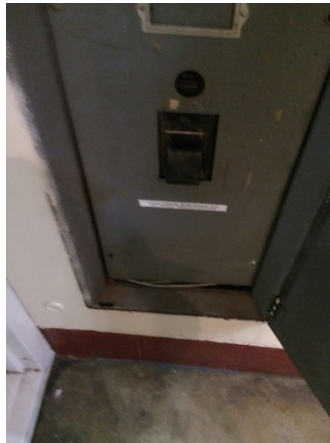
E.6 Electrical Panel cover not fitting properly and wires exposed.

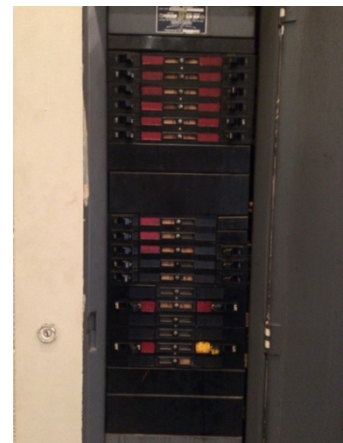
E.7. Electrical Panel cover not fitting properly.

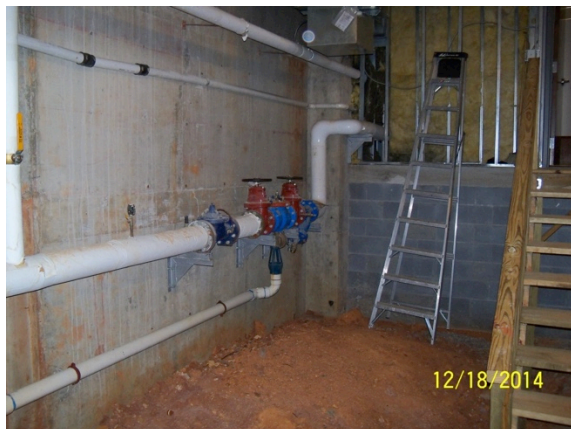
P.1 Piping

Water service consists of a single 4" high pressure water service main with a single pressure reducing valve and reduced pressure backflow preventer located in the dirt crawl space area below level 2. It was installed in 2008 as well as a new 8" fire service main to the facility. The fire service has three entrances from the one fire main supply line into the facility. The original below floor mains located in the arena area ruptured and had to be replaced with new mains to supply the facility. Piping material consists of copper, lined cast iron water main and galvanized steel pipe. Repairs or recent construction areas are all copper pipe material. The system is operational without any leaks noted.

We recommend an additional reduced pressure backflow preventer be added to the cold water service main in the crawl space for operational standpoint. If the one existing unit fails during an event the facility would be out of water until it is repaired.

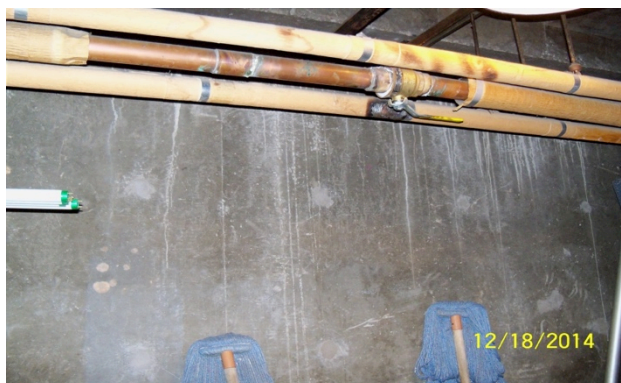
P.3 Insulation

Insulation in some of the original construction areas possibly contains asbestos. It was reported the system has had some abatement in the past. See P.3 & P.4 below.

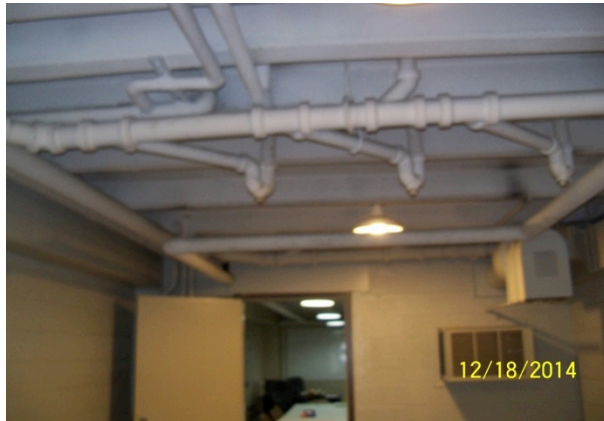
P.5 Screwed galvanized waste and vent piping material

The condition of the galvanized screw waste and vent piping is a concern. Although the piping appears to be good condition outside, it is a known fact this type pipe reduces interior area as time goes on, leading to ongoing service calls or leaks. The galvanized pipe will corrode from the inside causing a reduced internal diameter, which then causes reduced flow issues. Eventually the corrosion will lead to leaks and pipe failure. This piping appears to be the majority of the facility piping. The piping will need to be replaced to maintain operation of the facility for the next 5 to 15 years. It could not be verified if it was installed below the floor slab but observation says it was.

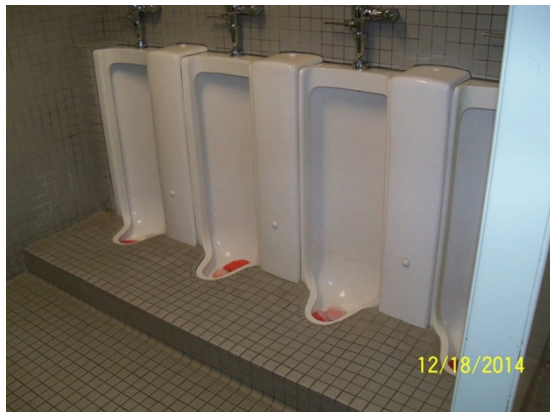
P.12 Plumbing fixtures – in floor urinals

The fixtures appear to be in relatively good condition with proper operation. A concern is the floor-mounted urinals are not a good sanitary type fixture, but they do operate normally.

The original in-floor urinals are in need of replacement with more modern wall hung units with separation barriers for privacy. While currently functional, these urinals are not ADA compliant, and with their age, there is always the concern of unexpected failure.

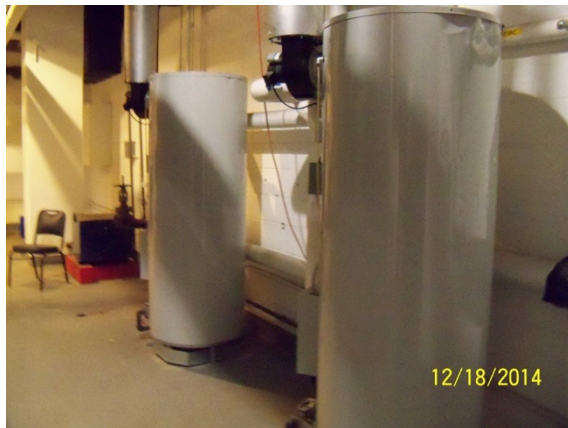
P.14 Gas water heaters

The domestic water heaters are in good condition and sufficient to meet the needs of the facility presently. Equipment replacement should be planned for in the next 6 to 8 years.

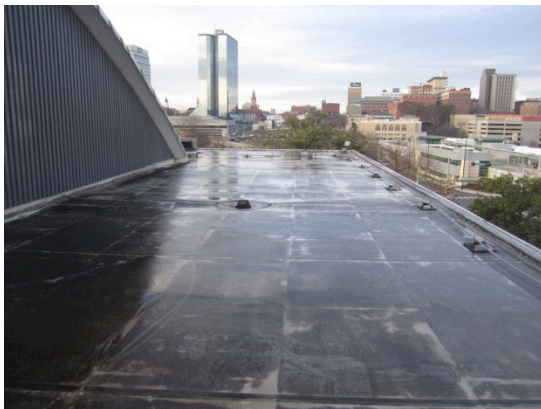
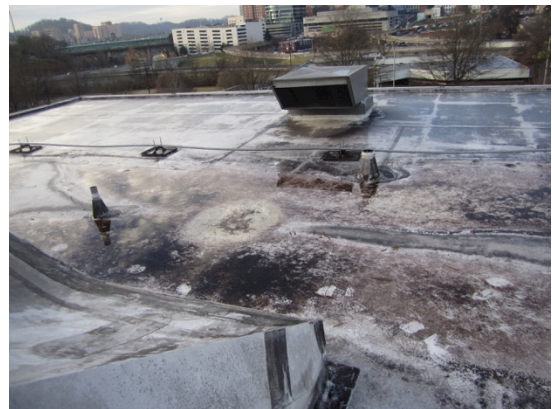
Roof mounted lights should include the use of a safety cable, especially needed since the mounting bracket is showing significant oxidation. Dislodged roof drain cover. All covers should be inspected and remounted.

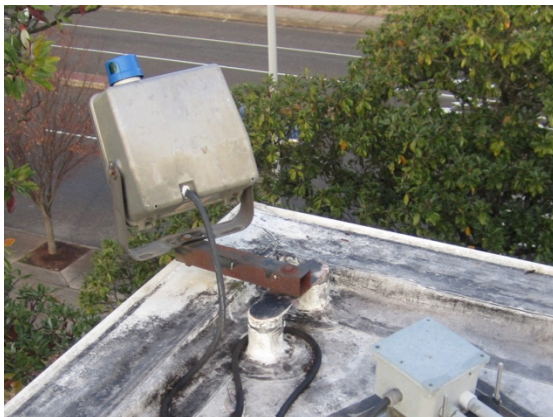
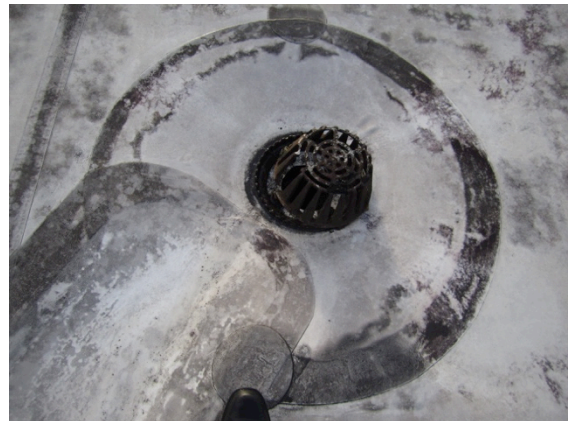
There is a dip in the roof membrane that may lead to standing water. Covering that has lost its adherence.

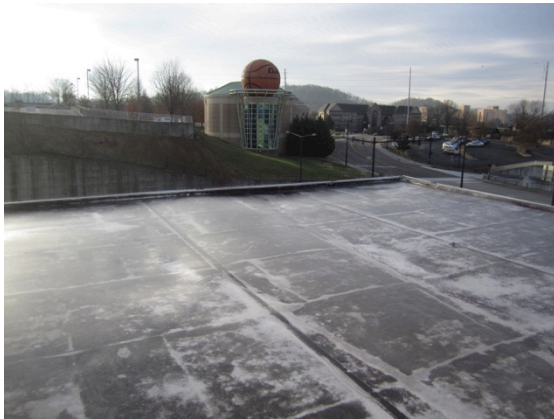
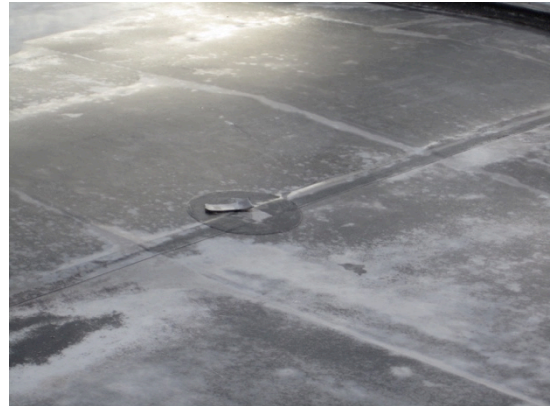
One of several instances of standing water (black spot at left). Standing water resulting in discoloration of the membrane.

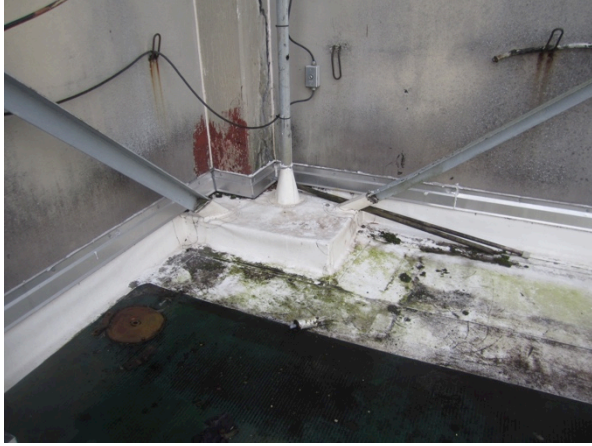
Clogged roof drain with built up organic debris. Standing water over time has resulted in discoloration of membrane.

For all three roofing systems, an annual inspection by a qualified roofing consultant should be conducted. A licensed professional may spot issues before they create larger problems that can occur from water intrusion, standing water, and the growth of vegetation in gutters and drains.

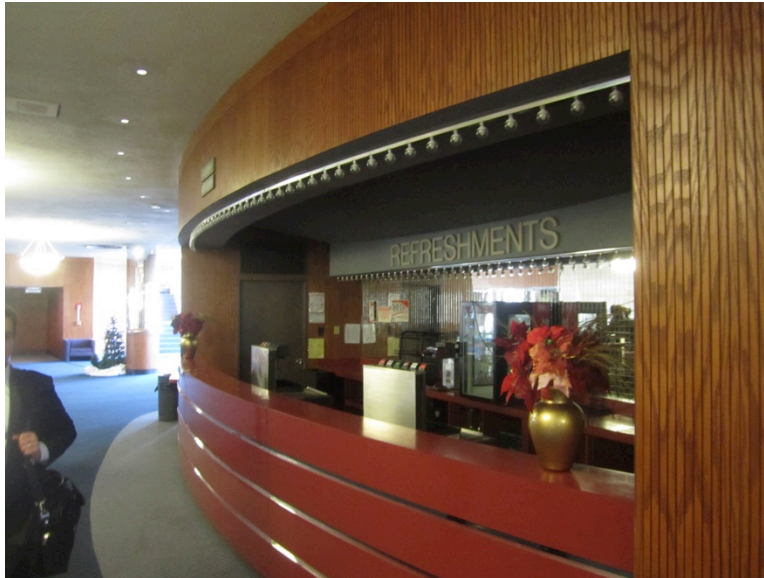
Main lobby concession stand. Equipment was in very good condition and the stand was clean. The main counter is not ADA height, although there is a portion that is lower (2nd photo) to accommodate wheelchair users.

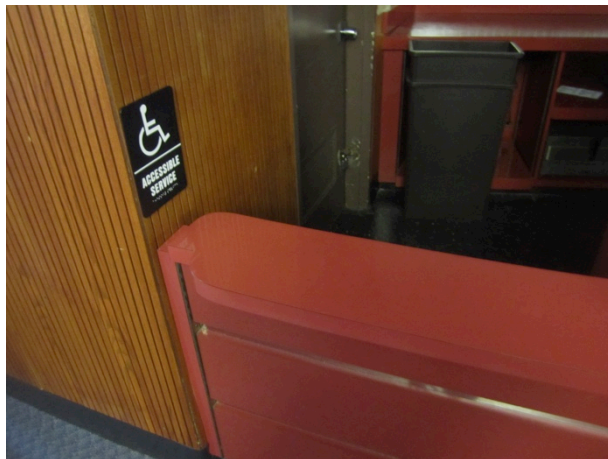
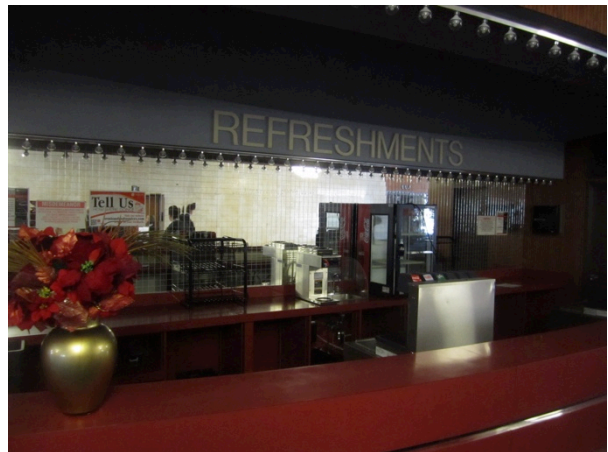
ADA counter at main lobby concession stand.

Lobby concession stand.

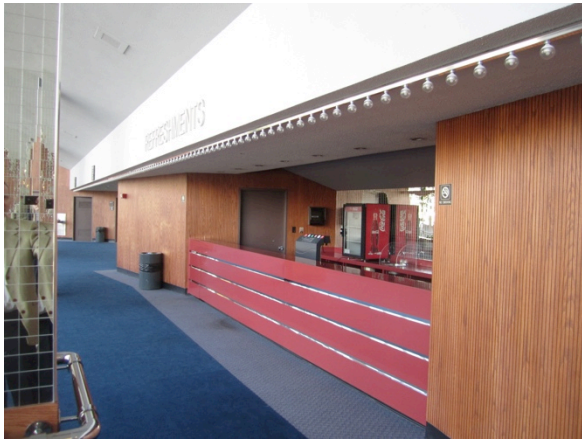
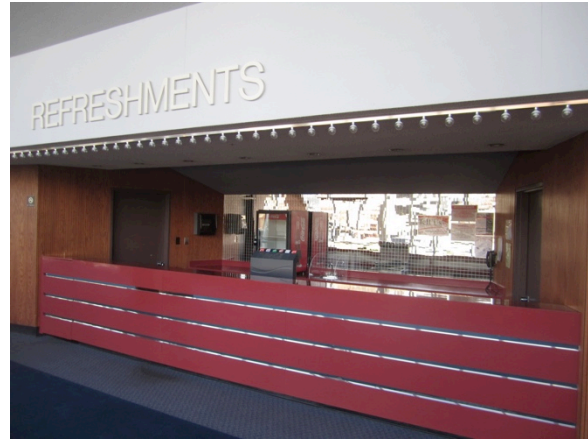
Balcony concession stand. Again, equipment was observed to be in very good condition.

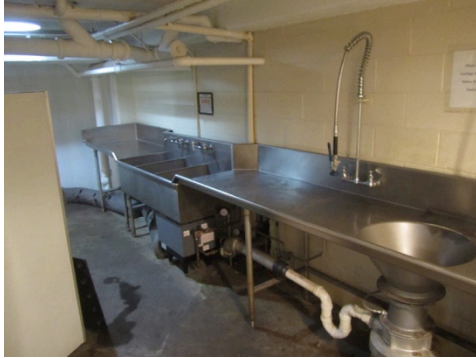
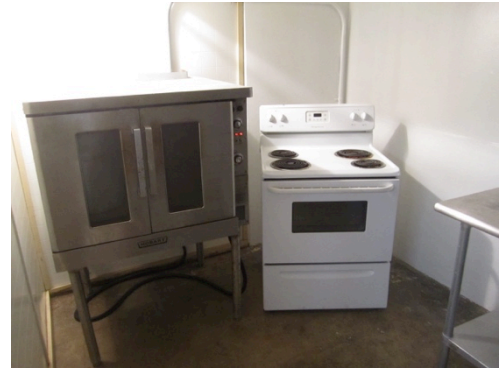
This is the cleaning area in the warming kitchen on event level. The equipment was observed to be in very good condition. Convection oven and residential-style stove/oven combo, in good condition, provide the greatest cooking ability outside of the individual stands.

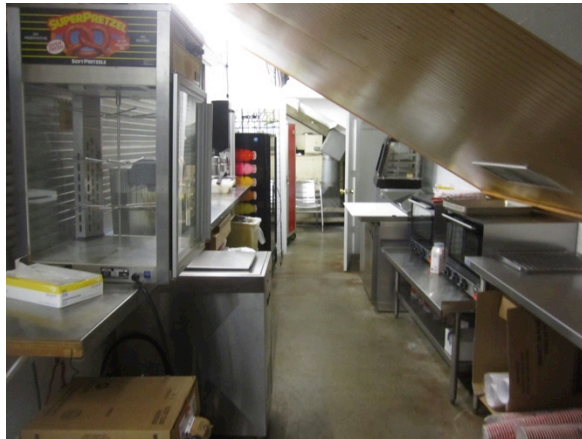
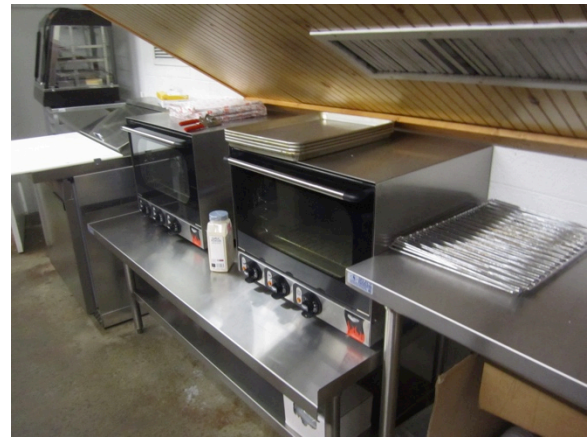
Interior of pizza concession stand on main concourse. Equipment was in good condition. Pizza ovens were in good condition.

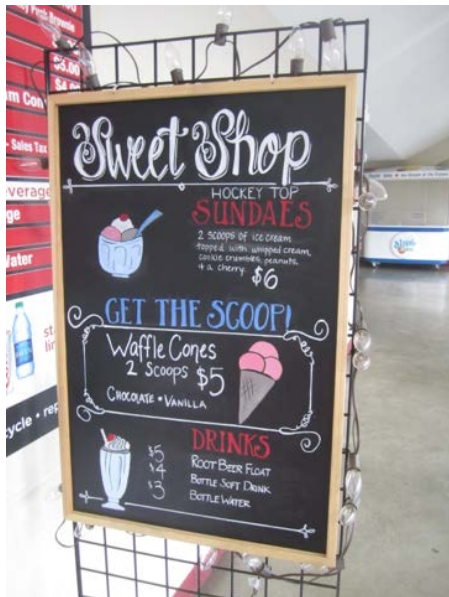
Signage for the dessert concession stand (permanent stand) on the main concourse.

Freezers were the main equipment in the dessert stand, and they were in good condition. We recommend ramping over the PVC drain that extends across the walkway in order to minimize the trip hazard as well as protect the pipe.

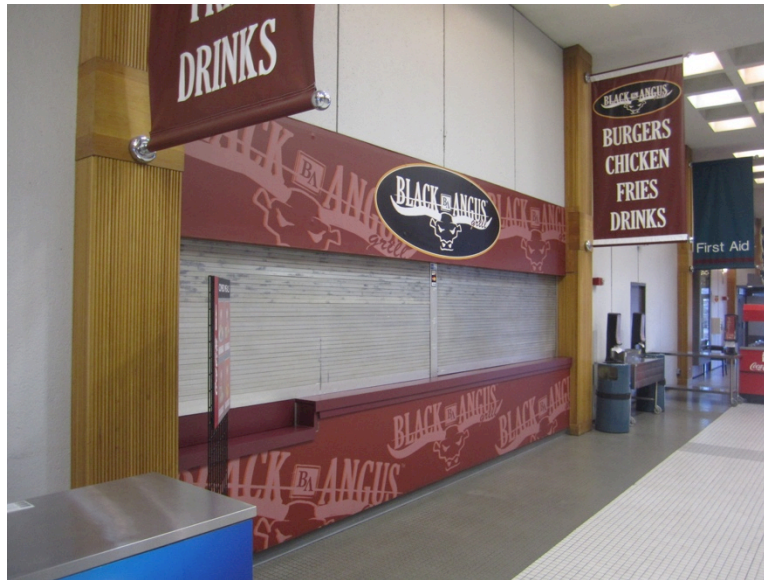
This is the only cooking (fryer and griddle) concession on the property, and it's located in the main hallway outside the Coliseum. This stand has the most appealing graphics. All the equipment observed was in good or very good condition.

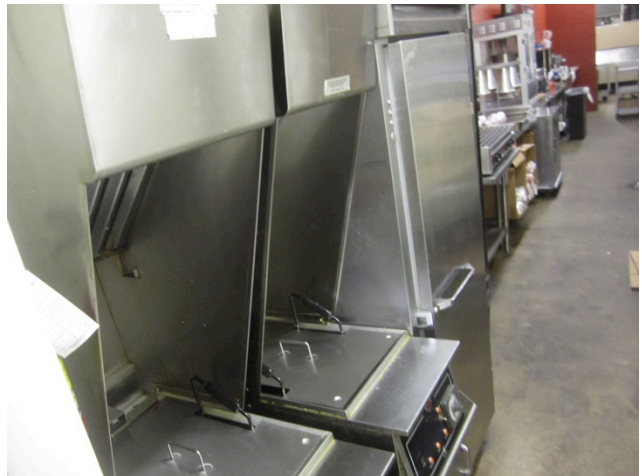
Two vent less fryers were in very good condition.

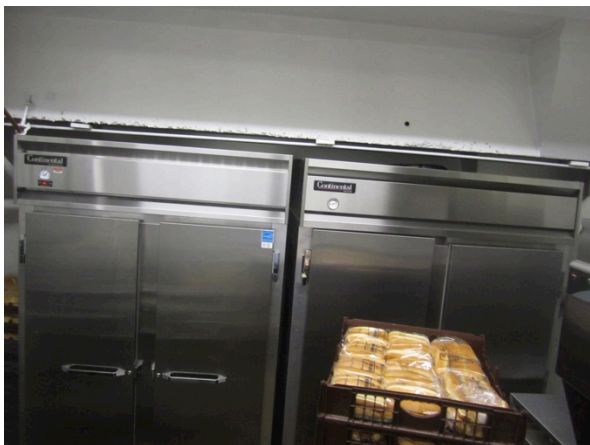
Refrigeration units were in very good condition. Freezer on event level was in good condition.

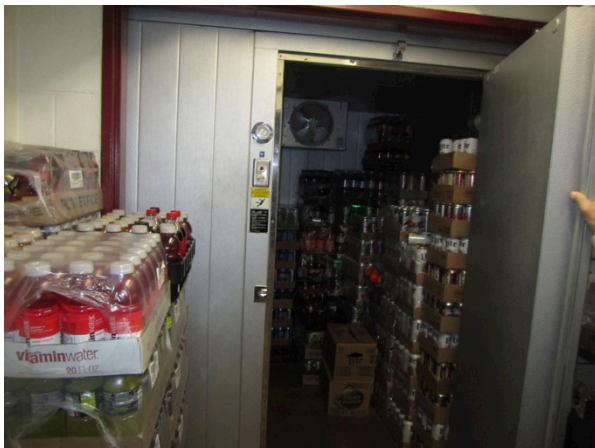
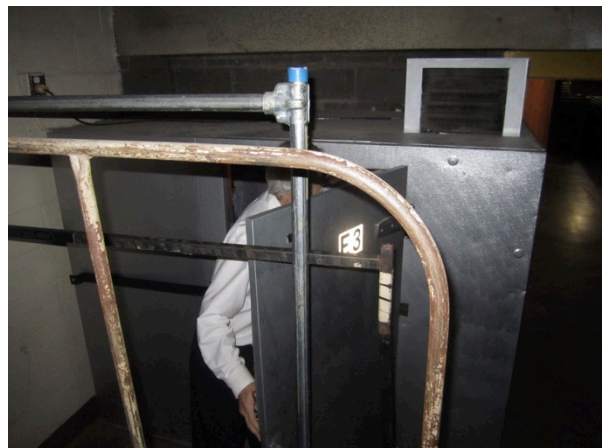
Walk in cooler on event level was in good condition. A second walk in cooler on event level was in good condition.

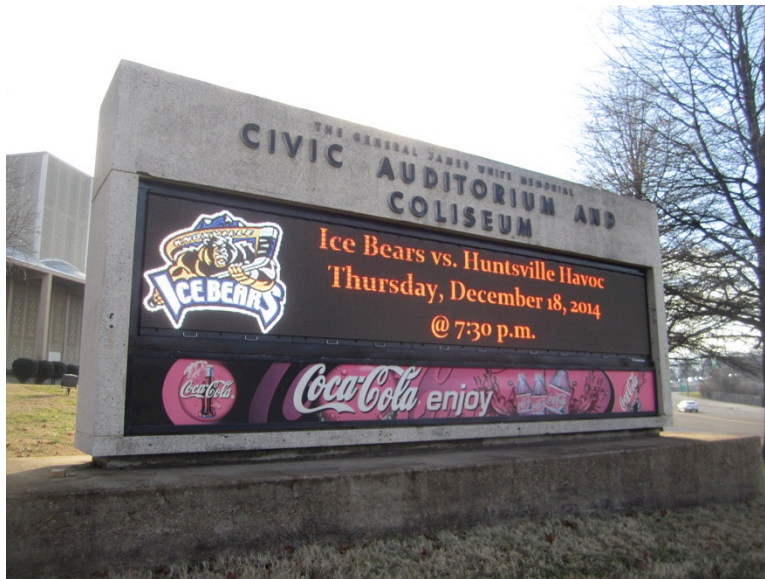
Exterior marquee at corner of
Howard Baker Jr. Blvd. and S Hall of Fame Drive.

The marquee housing appears to be an original structure from 1961, or constructed soon thereafter, but the video portion was installed in the fall of 2014. It measure approximately 4' tall x 21' long, and was installed by Datatronic Control, Inc. (Rowland, TX). The video board is full color with 10 mm pixel spacing. It is of a quality that is typically found in outdoor installations, and was observed to be functional and in excellent condition. While LED video boards can have a wide range of life expectancy, DCI has indicated the performance of this type of board will peak between years 5 and 7. After this time period, there can be a discernable level of brightness, and as with typical electronics, those components can start to fail. Towards the end of the warranty period for this sign we recommend compiling a list of electronic components, and for ones that can be replaced by building staff, maintaining an inventory of spares.

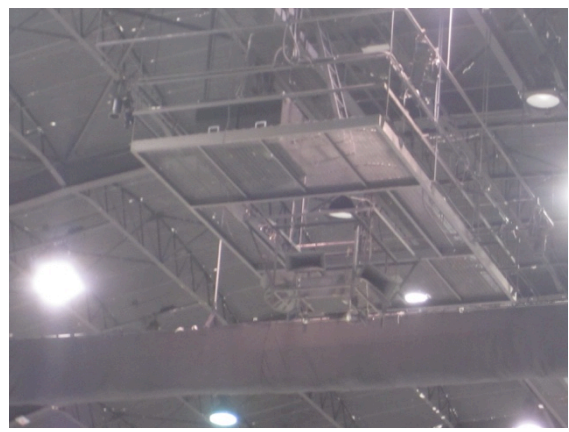
Coliseum sound system

The PA/sound system in the Coliseum was installed in 2005 and is adequate for permanent seating, but needs upgrading in the lower floor area in order to provide coverage. This is a common problem among smaller municipal buildings, and one that can be rectified at the time when the system needs to be replaced. If the current problem in this area at KCAC is significant enough, it may be worth hiring a sound design firm to develop a solution to address floor coverage.
